# **Navajo Abandoned Uranium Mine**

## **Site Screen Report**

### **NA-0405 AUM Site**

#### **Navajo AUM Northern Region**

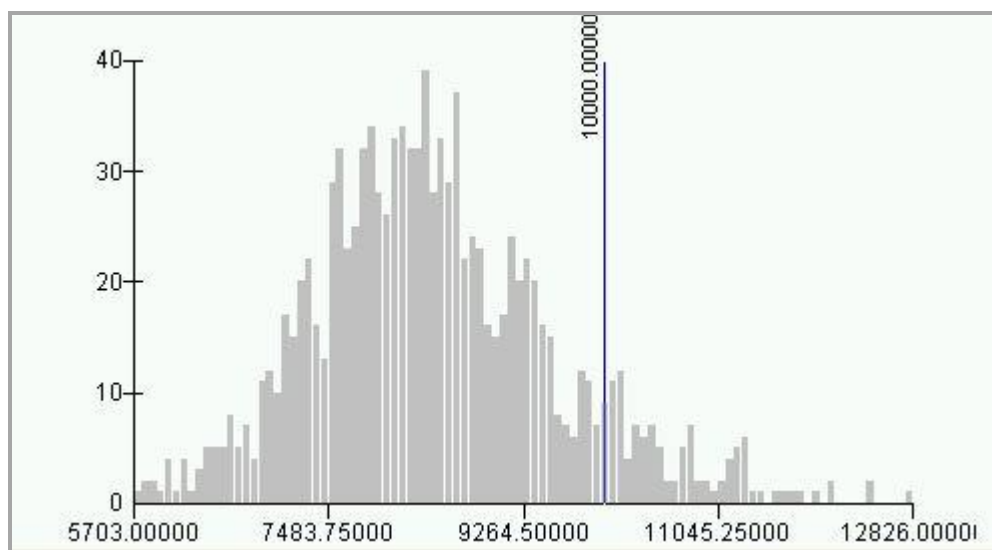
The following chart and statistics were generated by ESRI ArcGIS 9.3.1, and show the general distribution of the site gamma radiation measurements. The horizontal X axis represents the gamma radiation reading levels in cpm (lowest levels to the left). The vertical Y axis represents the frequency of each gamma radiation level.

Count:	1116
Minimum:	5703.00000
Maximum:	12826.00000
Sum:	9429066.00000
Mean:	8448.98387
Median:	8351.50000
Standard Deviation:	1111.74216

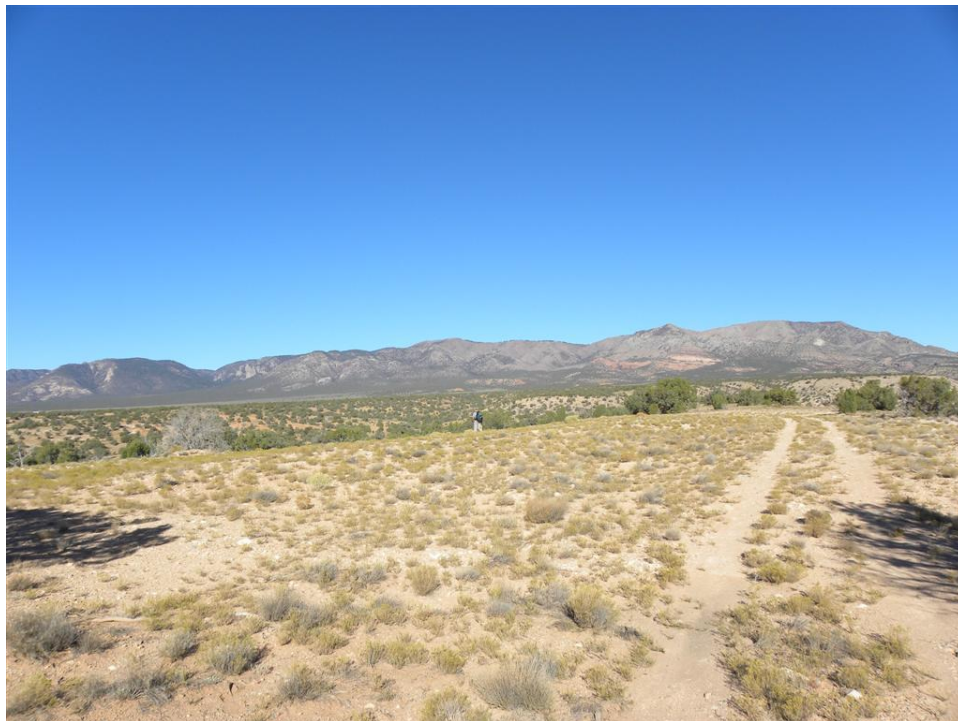
Photo 1. NA-0405 site

NA-0405 mine consists of an area of 5,959.52 m<sup>2</sup>. The mine was not identified as ever being operational. No other historical information or any additional ownership / lease information was identified in the EPA/AUM database.

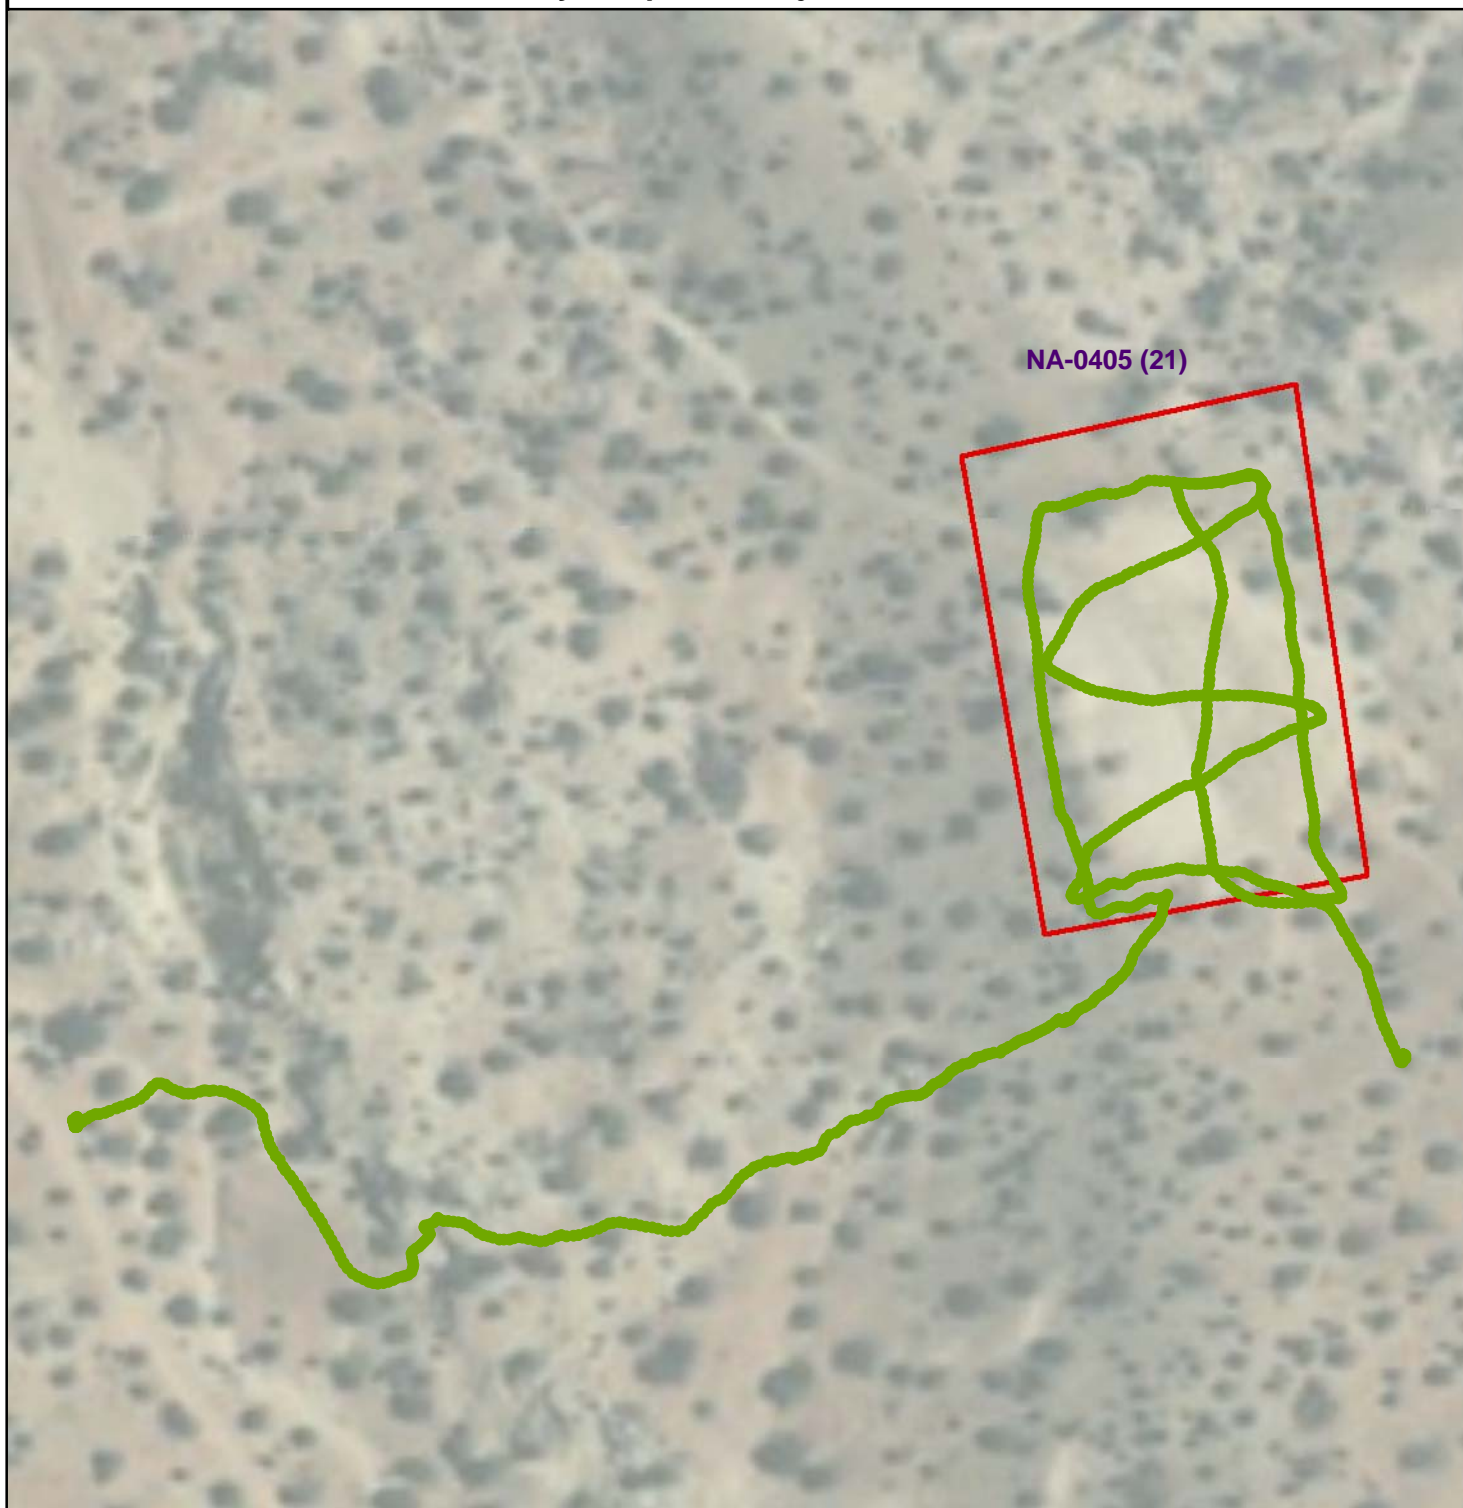
**Figure 1 - Gamma Radiation Measurements, Above Two Times Background  
NA-0405 (21)  
Red Valley Chapter, Navajo Nation, Arizona**

A total of 1,116 gamma radiation measurements were collected from the mine site, ranging from 5,703 cpm to 12,826 cpm. The measurements are represented in Figures 1 and 2.

Gamma survey conducted 10/2009  
Measured as counts per minute (cpm)

Average background = 9,494 cpm

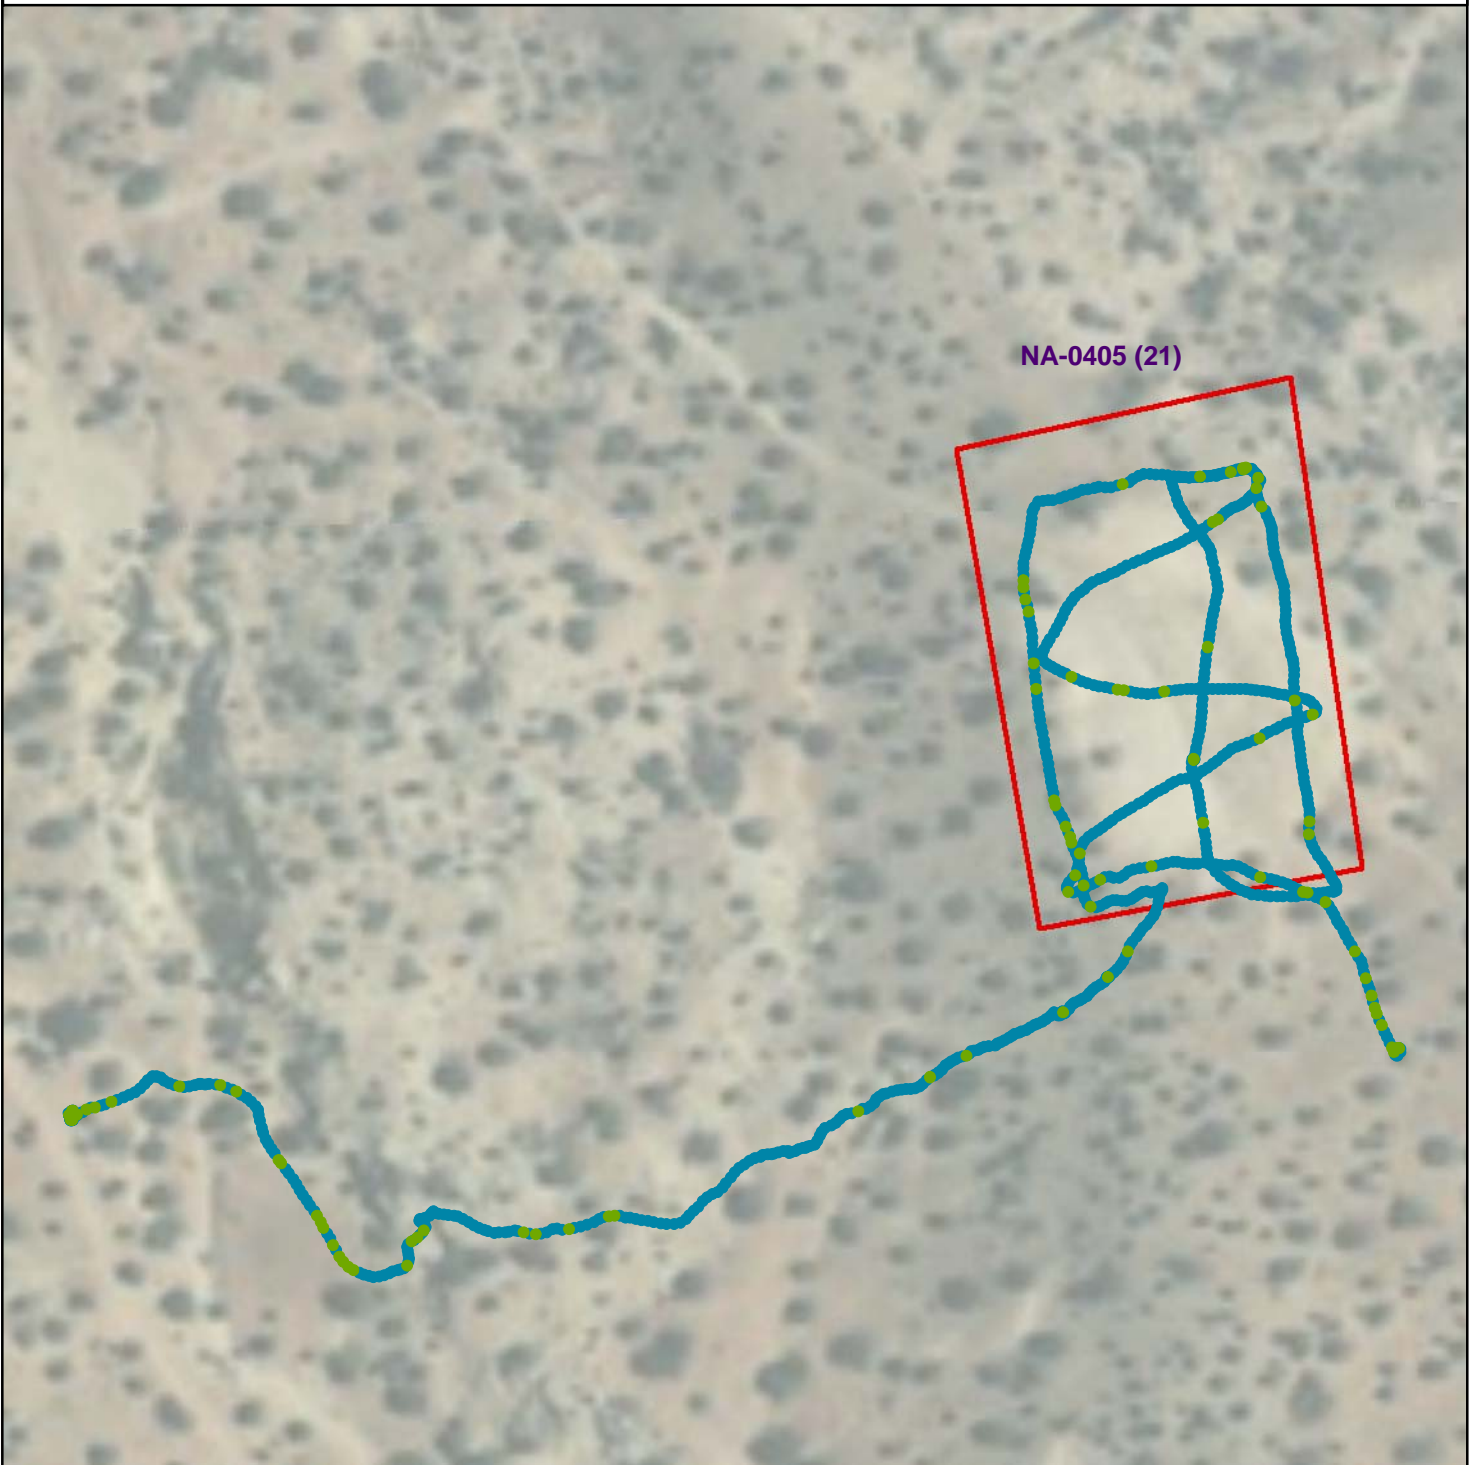
**Figure 2 - Gamma Radiation Measurements**  
**NA-0405 (21)**  
**Red Valley Chapter, Navajo Nation, Arizona**

Gamma survey conducted 10/2009  
 Measured as counts per minute (cpm)

Average background 9,494 cpm
